## Therma Gauge Type HG-Aln Repair Kit

HG-Aln Repair Kit

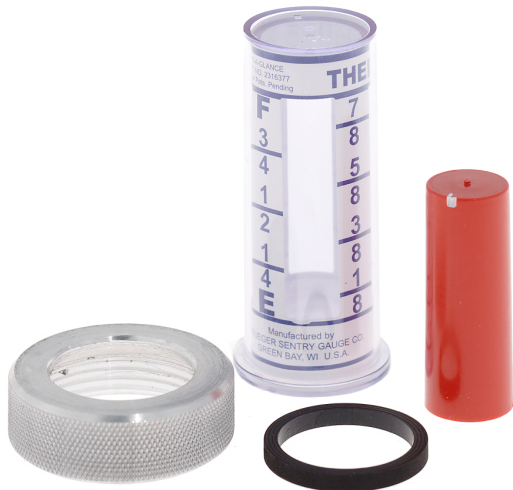
The Therma Gauge Type H Repair Kit is a quick and easy way to repair the most commonly replaced components of your gauge with one purchase. The repair kit will replace all of the non metal components located on top of your gauge (the exposed pieces on the outside of the tank.)

- Glass/Plastic Calibration (Cellulose Acetate) with UV inhibitor. The calibration consists of 3 components. An internal glass piece, an external plastic piece, and the calibrated paper in between the two.
- Aluminum Lock Nut
- Red Indicator Tube (HDPE Plastic)
- Gasket (Duro Nitrile)
